# SPLASH ZONE

Momentum Engineering called in Alocit Systems when problems arose with the original coating on a Turkish Petroleum offshore gas platform in the Sea of Marmara, Turkey. Momentum, specialists in offshore oil and gas rig design and installation, needed a tough, environmentally friendly coating that could be applied in the splash zone on areas of the superstructure that were unexpectedly exposed.

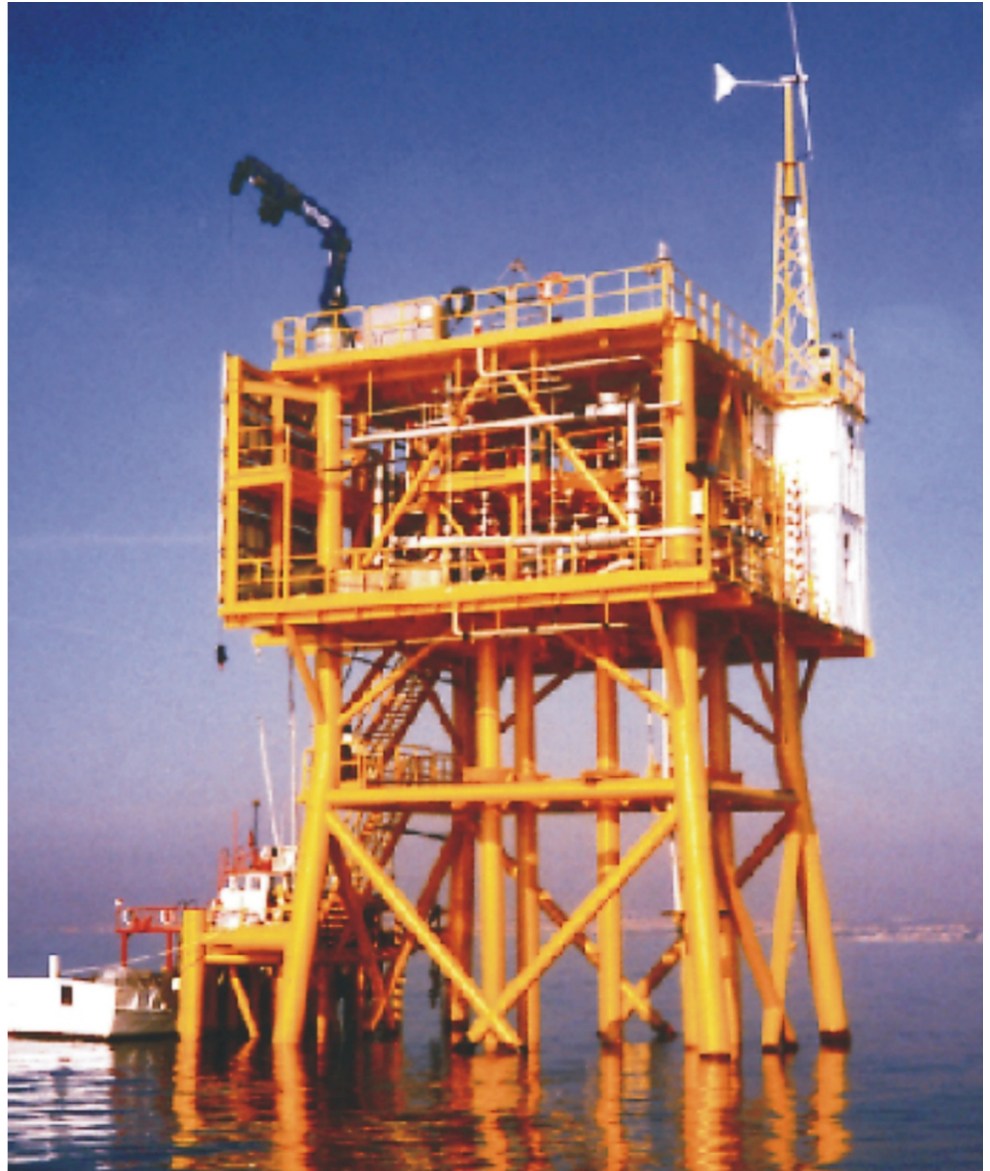
The superstructure had been brought overland in sections and coated before installation in approximately 145 feet of water. When the main platform was submerged the mud-mat over which it was situated proved to be significantly deeper than expected. The 5 feet depth of the mud-mat meant that an area, from a depth of 3 feet to two feet above the surface, required a coating to match the yellow top coat on exposed areas of legs and struts painted black because they had been expected to be below the surface.

*Above: The small platform in its idyllic coastal setting. At the sea level, exposed areas of the legs and struts that should have been submerged can clearly be seen without the yellow polyurethane top coat.*

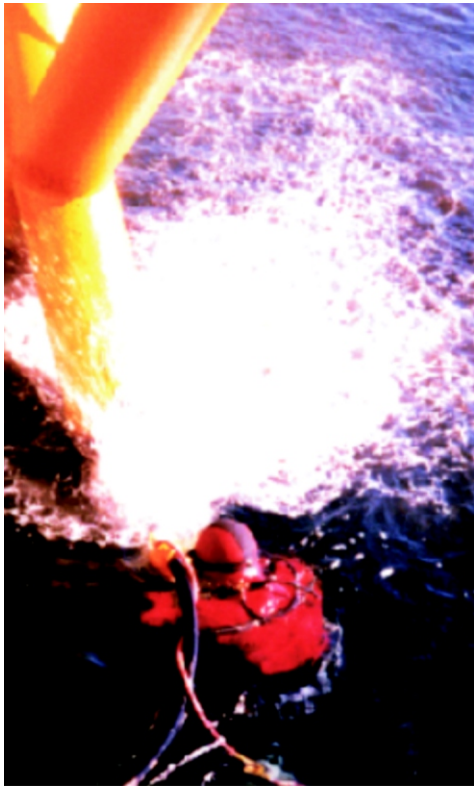
Top left: A diver prepares the surface for coating using grit-blasting equipment.

First, all the affected legs and struts were cleaned by divers using grit-blasting to remove marine growth and provide a surface profile for the Alocit System.

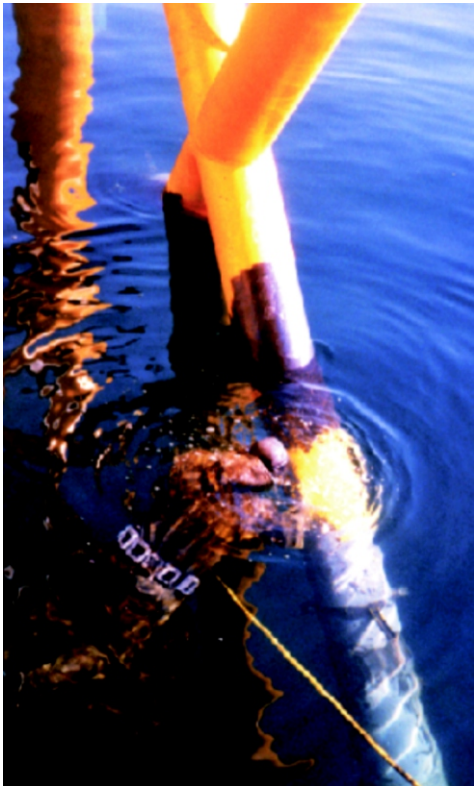
Top right: The coating is applied by hand brush straight from the tin. First, an index coating of black followed by a top coat tinted to match the original polyurethane.

Following the cleaning operation, A two-coat index system of Alocit 28.15 was applied. The first was black in order both to define the area being coated and to provide an early warning of damage to the final tinted top coat.

The second coat was tinted to match the customer's specifications and applied the same day, providing a cosmetic and hard wearing solution without any disruption to the normal operation of the facility.

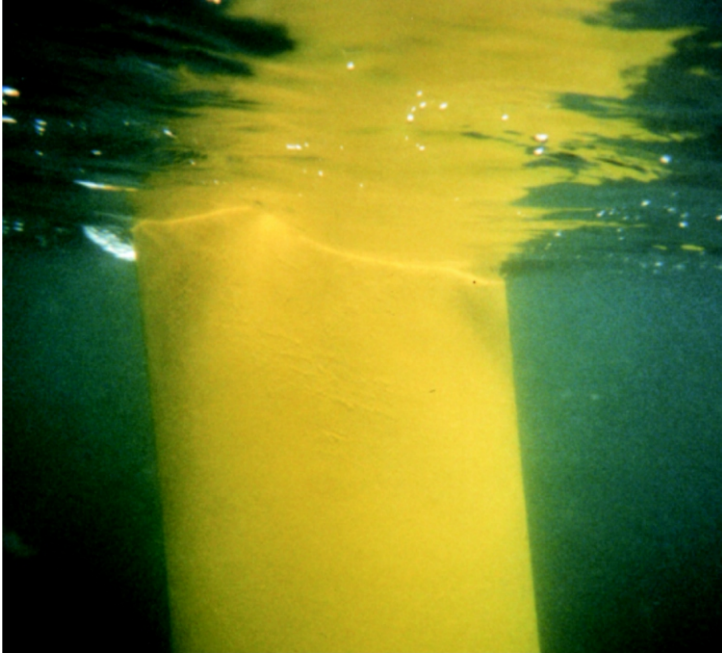
Bottom left: The finished repair is indistinguishable from the rest of the structure.

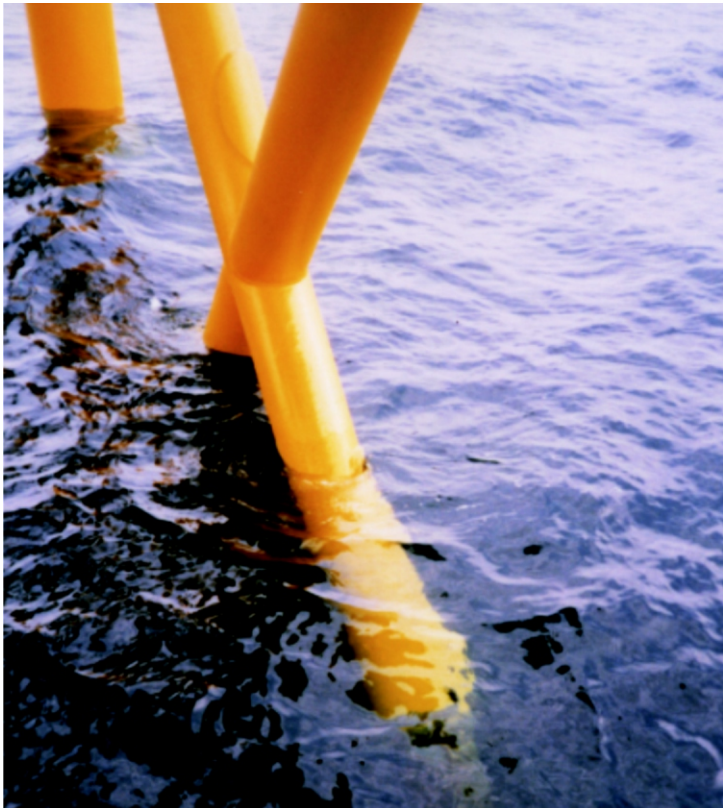
Bottom right: Underwater, the leg can be seen to be fully coated and protected.

With regular maintenance checks for abrasion or impact damage, the coating has a life-expectancy of ten to fifteen years.
