## **North American Limestone Mining**

In February of 2011, Enviropeel was installed on conveyor belt pulley bearings in a central Indiana aggregate limestone quarry. Twenty-four new bearings in particularly harsh locations were chosen to be encapsulated with Enviropeel due to their exposure to constant limestone dust and the water used to wash the aggregate.

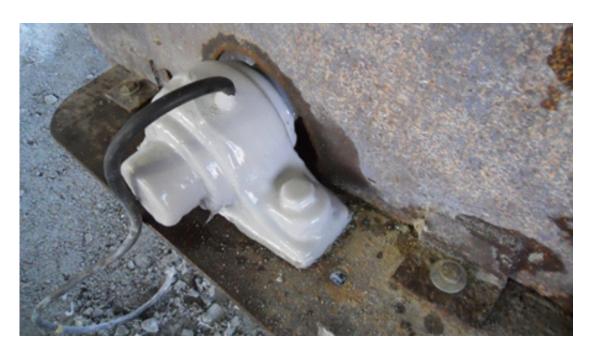
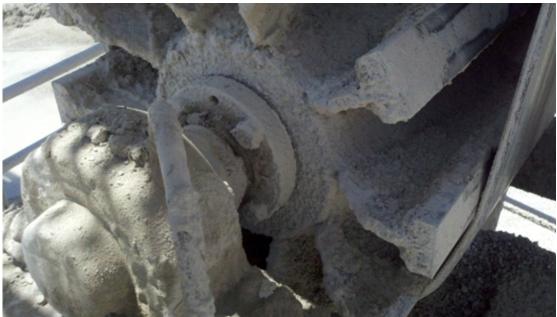
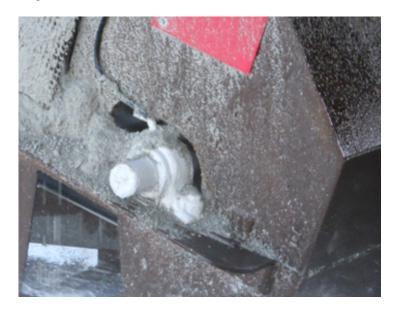
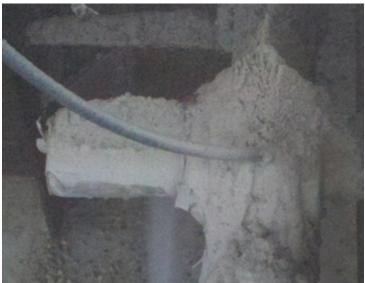
Above and below: before and after pictures show the difference between a new application and what it looks like after a year of exposure to mine conditions.

After one year of Enviropeel protection, all coated bearings are still in operation with no sign of failure. Due to the isolation of the bearings from contamination, lubrication frequency has been significantly decreased, resulting in lowered maintenance costs. Additional benefits include rotating shaft protection and the ability to eliminate some previously required mechanical guards. The plant manager estimates a savings of over \$20,000 in bearing costs alone in this first year of protection. This does not take into account the savings from downtime, labor for replacement, or lubrication savings. Given the success of Enviropeel in this plant, implementing our product into other area plants has begun.
