## PROTECTING THE EDGES

## How moisture ingress is prevented using Enviropeel

THERMOPLASTIC ANTI-CORROSION SYSTEMS

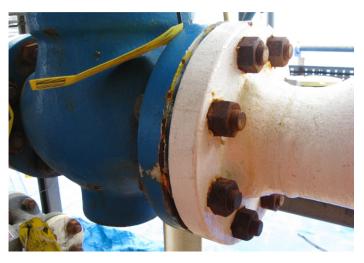
A standard Enviropeel application, as shown in Fig 2, encapsulates all the vulnerable areas and continues the coating until a reasonable area of intact coating has also been covered.

Fig 1: typical substrate prior to use of Enviropeel Fig 2: typical Enviropeel application

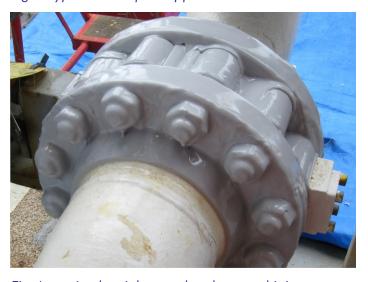
Fig 4: a mixed stainless and carbon steel joint with carbon steel bolts with Enviropeel encapsulation removed after more than 6 years

Although, on the unpainted steel test substrate in Fig 3, a small margin can be detected where moisture meets the inhibitor, on a painted substrate the effect is completely insignificant. All the vulnerable areas are locked in a moisture-free, inhibitor rich environment, away from any potential ingress. The example in Fig 4, shows a substrate which, without encapsulation, would have bolts failing within 18 months because carbon steel bolts in a stainless substrate suffer badly from galvanic corrosion. As can be seen, no corrosion has occurred within the encapsulation.

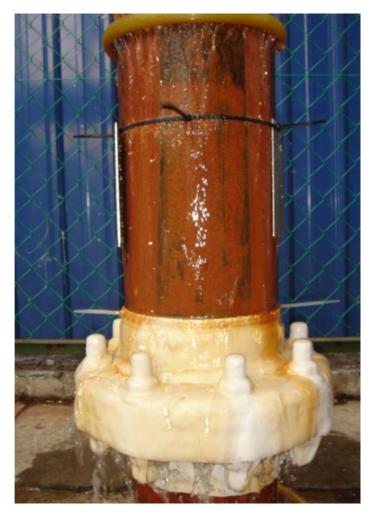
Fig 7 right: substrate after three months, just prior to removal of Enviropeel

For the test, an uncoated carbon steel pipe and flange test piece was placed in a stream of 20% salt water. To emulate splash zone conditions, the flow was turned on and off on a 12 hour cycle.

To ensure no protection of any kind was on the substrate, a 15cm strip was abraded with an angle grinder (to remove mill scale etc) along the whole length of the pipe.

The test was run over three months, following which the Enviropeel was cut away to reveal the results.

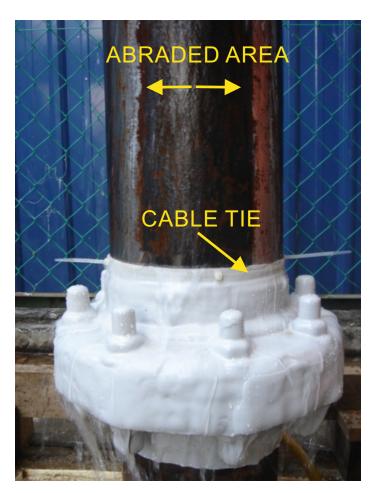
Fig 5 above: substrate and Enviropeel encapsulation shortly after the beginning of the trial. On potentially vulnerable edges, cable ties provide extra security.

Fig 6 left: two weeks into the trial, the circular water delivery system can be seen at the top of the photo.

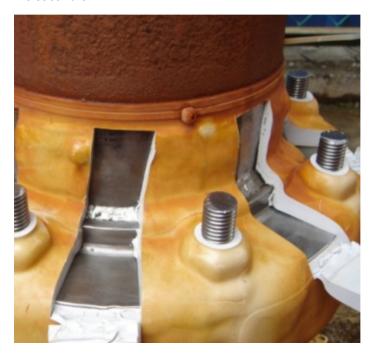
Fig 8 below: intially, strips of Enviropeel are removed from the substrate.

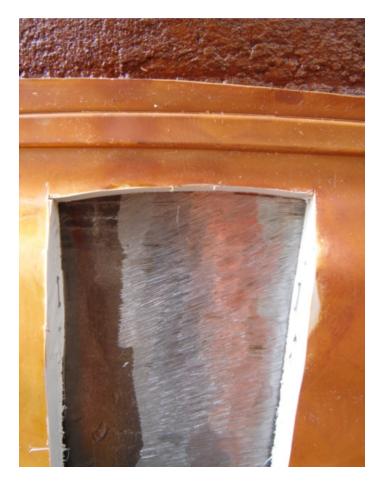
Fig 9 above: the removal of the mill scale is clearly visible

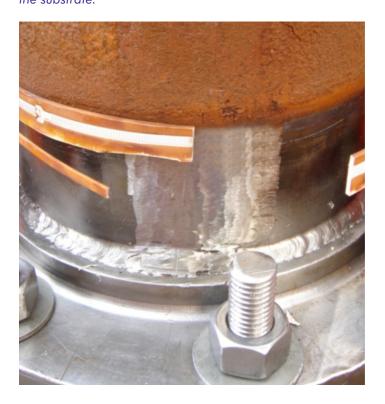
Fig 10 above right: following removal of all the Enviropeel material from the joint, the level of protection is clearly visible.

As this test shows, despite the high salinity and constant flow of water, no corrosion or penetration of any kind can be seen within the Enviropeel encapsulation.

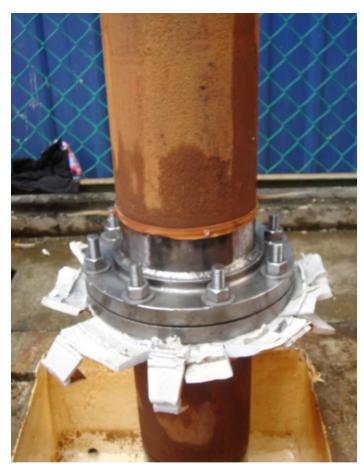
Figure 11 below: cutting through the sealing tie reveals a sharp line between the protected and unprotected areas of the substrate.

Because Enviropeel cools and contracts on to the substrate, with a constant release of inhibiting oils, moisture is prevented from entering the interface. Where there is likely to be substantial or sustained water pressure, extra material is applied and cable ties are employed to provide extra security. Sealing upper edges securely is particularly important as these are the areas that are subject to rain and water flows.
