FLOORING

Alocit coatings are particularly suited to flooring applications. With high surface tolerance, ease of application and extreme durability they offer a perfect solution - particularly on damp, oily or other types of contaminated concrete. In this example, although of fairly recent construction, the concrete flooring in this factory unit had become unsightly, with patches of ingrained dirt and oil as well as cracking and pitting. The degree of contamination meant that the new coating would have to adhere to a surface with areas that retained considerable quantities of oil despite thorough cleaning.

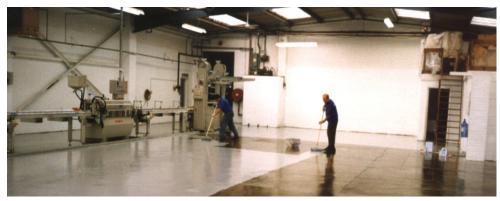
The pictures show, from the left, stripe coating the edges, application of 28.95 then 28.15 by roller and, finally, the finished floor.

The floor was cleaned using a highpressure water jet with surface water removed by vacuum machines. This was followed by crack filling with 28.96 and a stripe coat of 28.95 around all the edges. The entire floor was then primed, producing a perfect surface for the application of the finishing coat.

The materials were applied using a roller, with wet film thickness testing at all stages to ensure an even coating. The primer coat was 6 mils and the top coat 12 mils, giving a hard wearing and attractive finish to the factory floor.
